COMPILATION OF  
MATERIALS RESEARCH DATA

AR-592-1-374

11 December 1962

SUBJECT: Metallographic Examination of Radiographically Detected Defects in Resistance Spot Welds in 0.010" thick 301 Stainless Steel Centaur Intermediate Bulkheads.

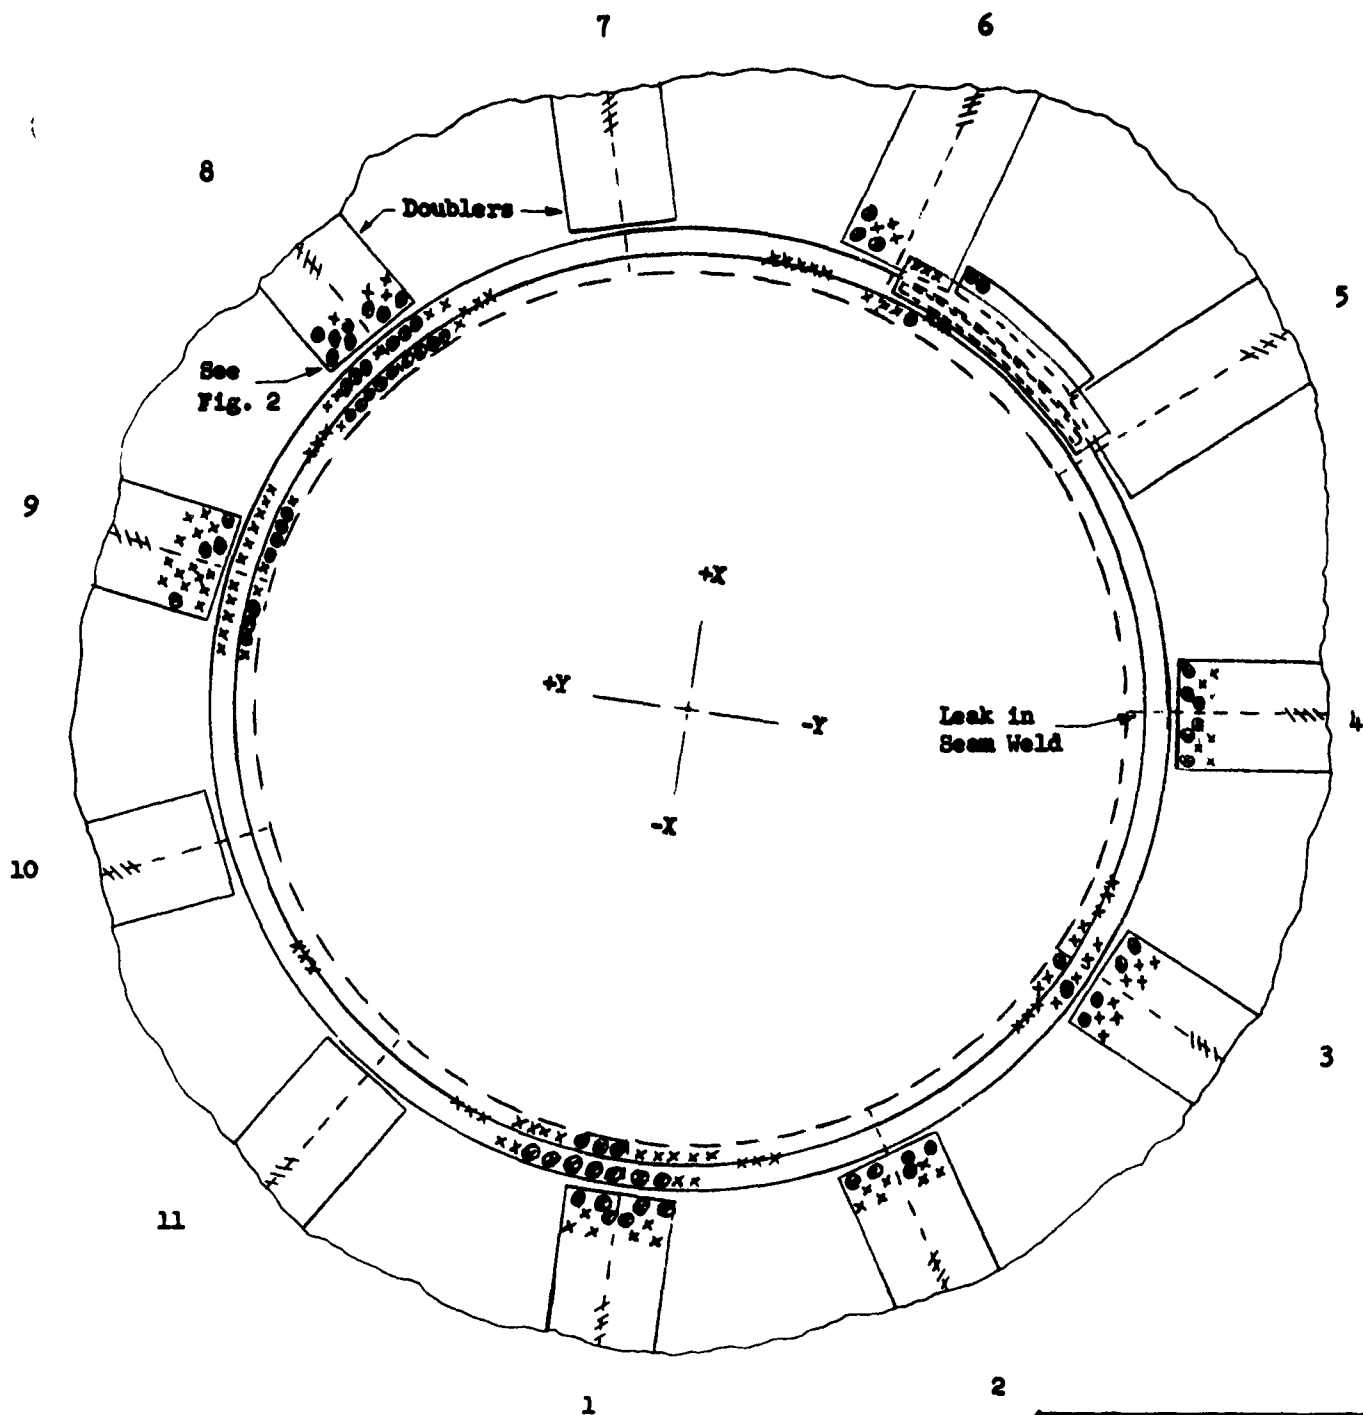
Spot Welds from the Structural Bulkhead. A sketch of the structural bulkhead is included to show the location of two spot welds which were removed from the bulkhead for microscopic examination of the defects, as recorded radiographically (see Fig. 1).

Fig. 1. Cap Area of the Structural Bulkhead from the first Centaur C-2. View looking forward which shows the locations of the resistance spot welds in which radiographic inspection detected defect indications.

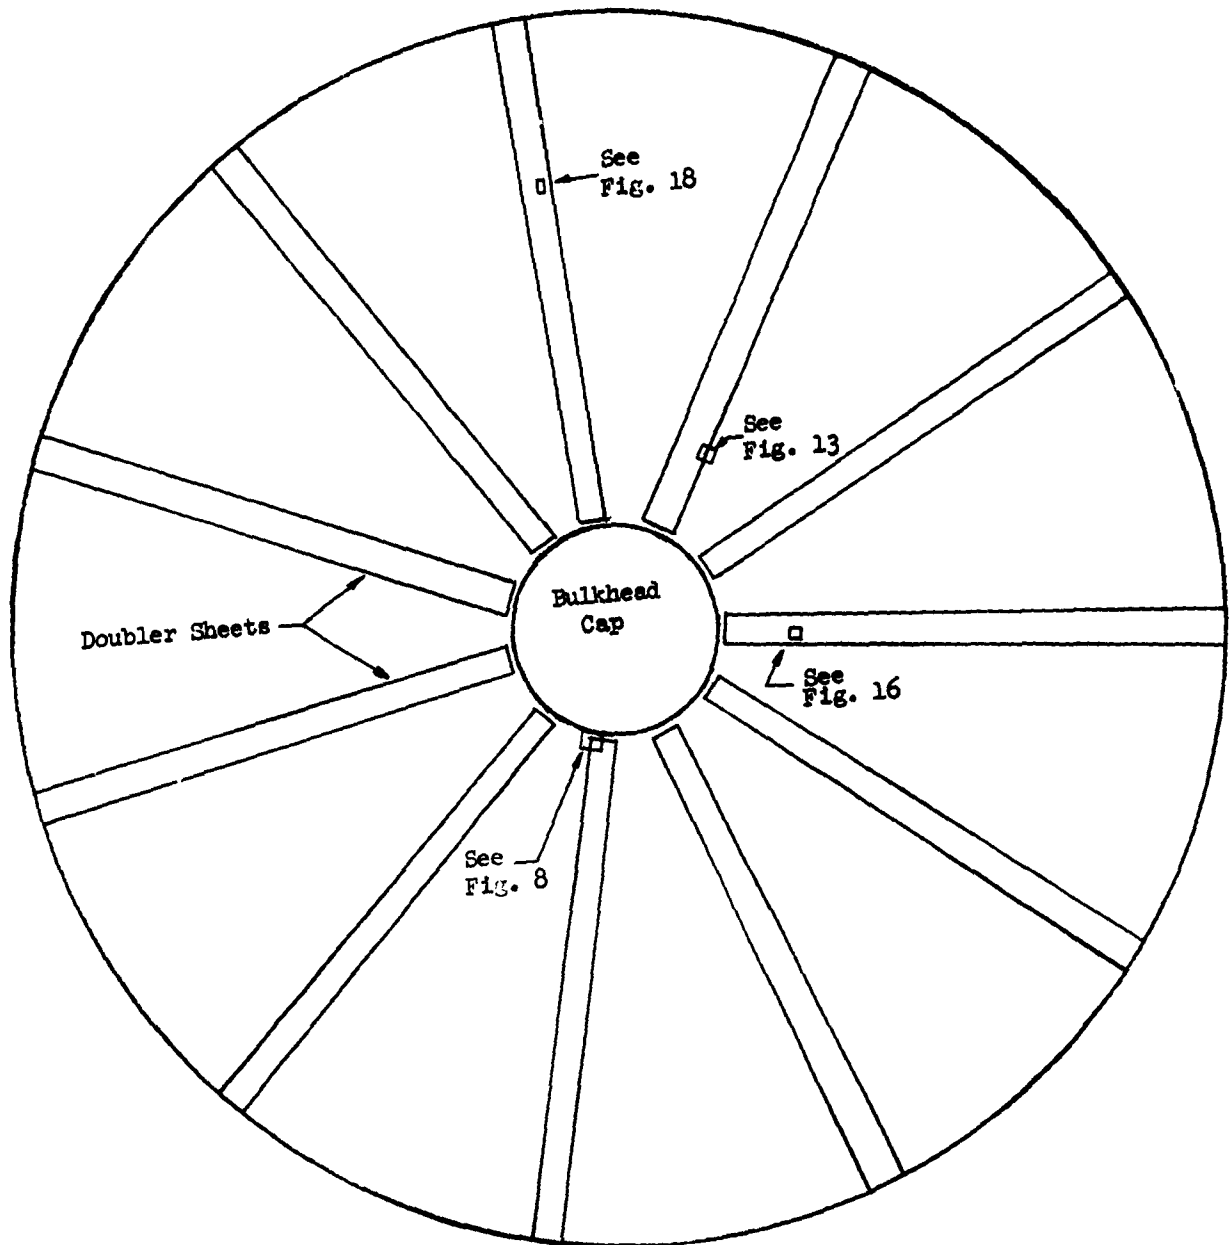
Spot Welds from the Spring Ring Bulkhead. A sketch of the spring ring bulkhead is also included to show the location of the five spot welds which were also removed from the bulkhead for microscopic examination of the defects as recorded radiographically (see Fig. 7).

Figure 7. The above sketch shows the location of the two spot welds shown in Figures 8, 13, 16 and 18. The sketch represents the Spring Ring Bulkhead of the first Centaur C-2.

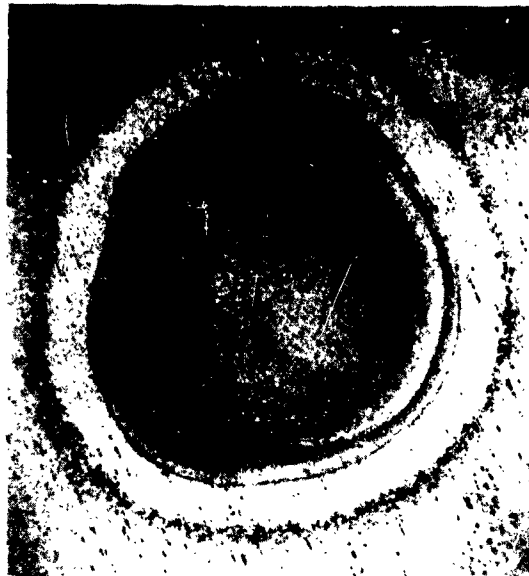
The photomicrographs of the two spot welds shown in Figures 15 and 17 illustrate that the radiographically detected defects are corrosion pits at the faying surface of the two sheets in the carbide precipitation zone. The resistance to corrosion attack is lowered in the carbide precipitation zone of a 301 stainless steel weld because the chromium content in these areas is depleted during the heat cycle of welding. A corrosive fluid may have become entrapped at the faying surface and the subsequent pits were formed.

Figure 17. Photomicrograph of a plan view of the spot weld shown above. The grinding and polishing of this mugget was performed on the doubler sheet. This defect was located in the gore skin since 0.011" was removed by grinding and polishing. When compared to the radiograph, it is seen that this photomicrograph shows the mugget in a view which is turned slightly counterclockwise. This defect, like the one in Fig. 15, also appears to be a corrosion pit at the carbide precipitation zone.
